**DRAFT
MEMORANDUM**

Subject: 3066 Flying C Road Culvert Structural Evaluation

Date: July 24, 2023

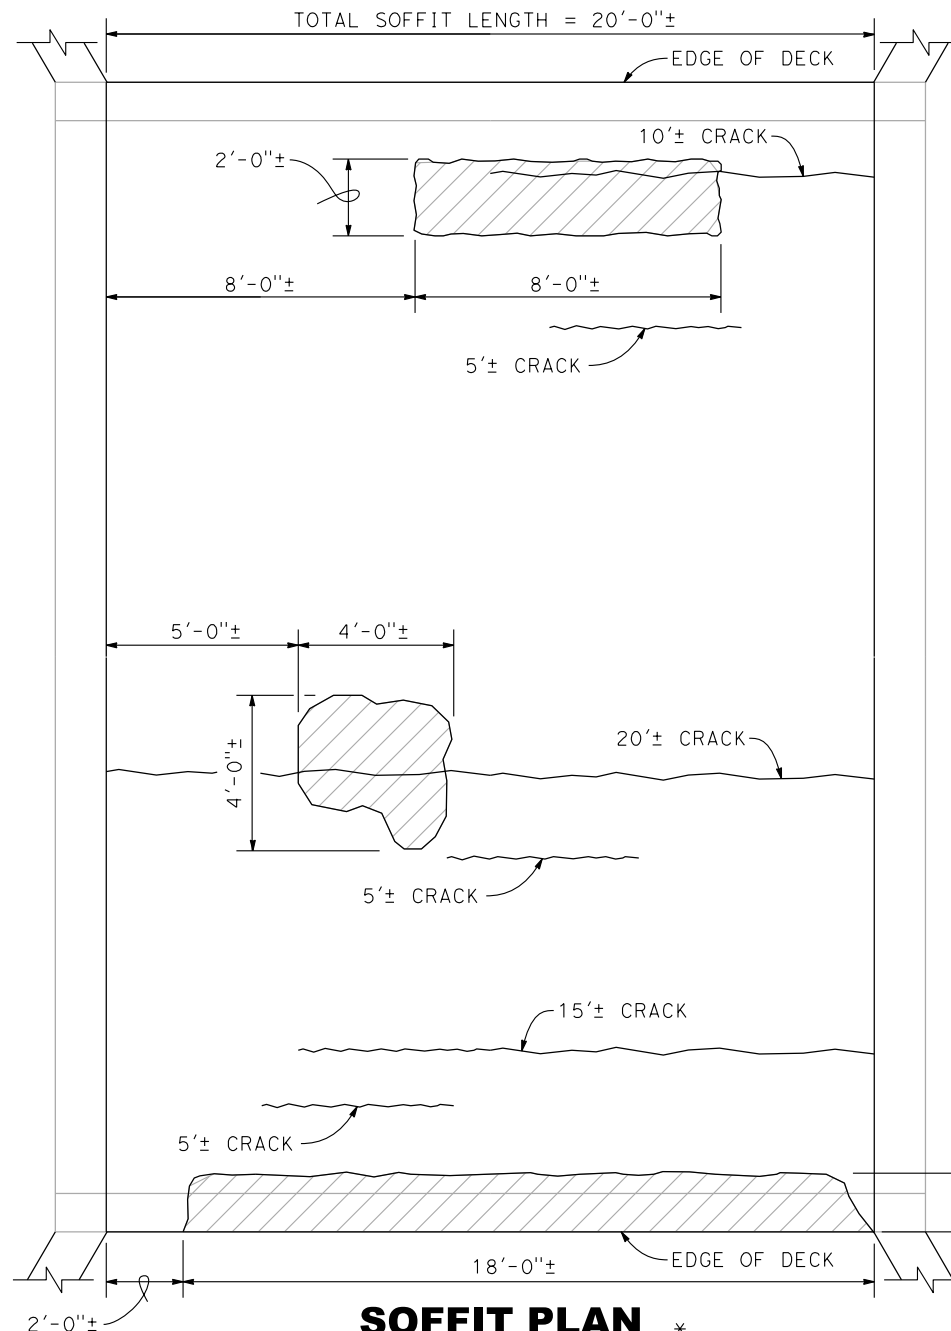
SOFFIT PLAN

- There is spalled concrete at several of the railing post locations where the posts were broken out of the culvert by flood debris.
- There is spalled concrete along the bottom corner of soffit at several location on both the north and south sides of the culvert. These appear to be corrosion-related and are surrounded by areas of unsound concrete.

- There are several longitudinal soffit cracks concentrated near each edge of the culvert slab, but also a number closer to the center. Several of these also exhibit substantial areas of unsound concrete along their lengths and extending up to 5 feet from the edge of soffit.

- There is an area approximately 4 feet square centered about 7 feet from the west abutment wall and 12 feet from the south edge of culvert that exhibited an unusually deep noise indicating some level of delamination, but not typical of surface spalling. Dokken was unable to identify the

source of this phenomenon. It may be related to a horizontal plane of delamination closer to mid-depth of the 1'-10" deep slab. Taking cores through the deck would be the most effective way to determine the cause.

- Remove unsound concrete along the corners of the deck slab to approximately $\frac{3}{4}$ " beyond the nearest longitudinal bar. Clean reinforcement and treat with corrosion inhibitor. Install drill and bond dowels if spalled areas are greater than 4 inches deep. Patch with material suitable for overhead construction per the Caltrans Authorized Materials List.

- Epoxy-inject soffit cracks.
- If analysis of cores indicates a layer of unsound concrete on the soffit, remove and patch as described above for the deck slab corners.
