Ch 3. Identifying distresses

A variety of distresses can occur on a flexible pavement. This chapter explains how to identify each distress and its various levels of severity, what causes the distress, and how to measure the distress (for a survey). The level of severity governs what treatment may be used and is defined as low (L), medium (M), or high (H).

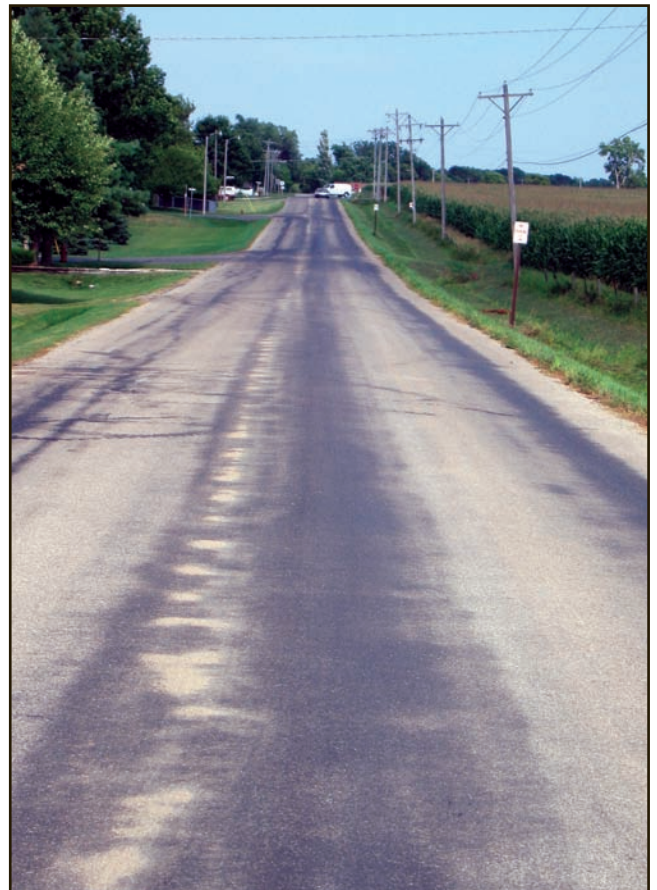
Figure 5. Low levels of bleeding are often the result of too much asphalt binder being pushed to the surface, but aggregate is still exposed, and asphalt does not stick.

Asphalt binder is pushed to surface of the pavement and the appearance is usually shiny and black. Bleeding can occur over the entire pavement but is more common in wheel paths.

Asphalt mix was too rich with binder or too much binder was applied on a seal coat. Traffic works aggregate into the pavement, collapses air voids, and pushes excess binder to the surface.

Low—Bleeding has occurred to a slight degree. Aggregate is still exposed on the surface. Asphalt does not stick to shoes (figure 5).

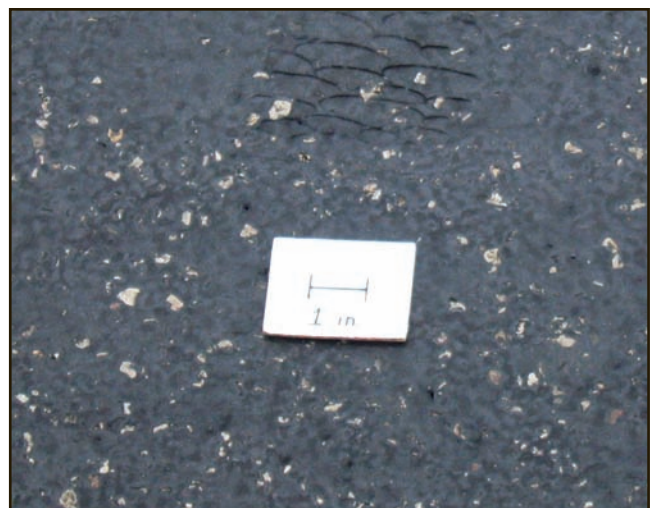
Figure 6. In high ratings of bleeding on pavements, shoes and tires stick to the surface and aggregate is barely visible.

High—Bleeding has occurred to the extent that asphalt sticks to shoes. Shoe soles and tire treads are left in the surface. Aggregate is barely visible (figure 6).

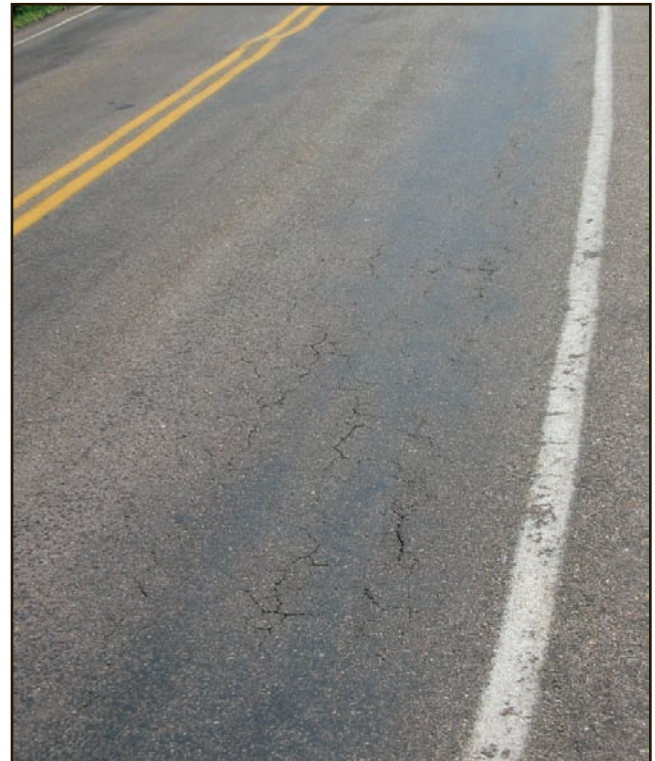
Figure 7. Low levels of alligator cracking begin with a few hairline longitudinal cracks, but pavement do not pump under loading.

Alligator cracking is a structural distress composed of interconnected cracks that have the appearance of alligator scales. Alligator cracking is typically found in wheel paths and may be accompanied by rutting.

Alligator cracks form in areas of repeated traffic loads. The traffic loads cause high stress in the bottom of the pavement. This stress cracks the pavement starting from the bottom and working up to the surface. The cracking begins with hairline longitudinal cracks in the wheel paths and, as the pavement ages, the cracks begin to interconnect and form small blocks.

Low—Longitudinal cracks have formed, but few interconnecting cracks have formed. Cracks are tight and have not spalled. Pavement does not pump under loading (figure 7).

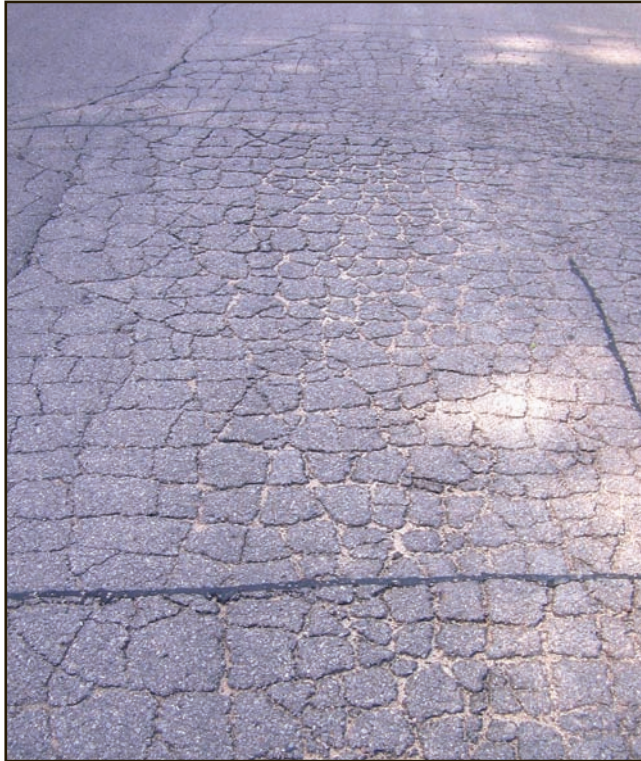
Figure 8. High alligator cracking is a network of cracks that have formed and grown into blocks. Areas where dense cracks have formed pump when loaded.

High—A dense network of cracks has formed. Cracks have spalled. Pavement pumps when loaded (figure 8).

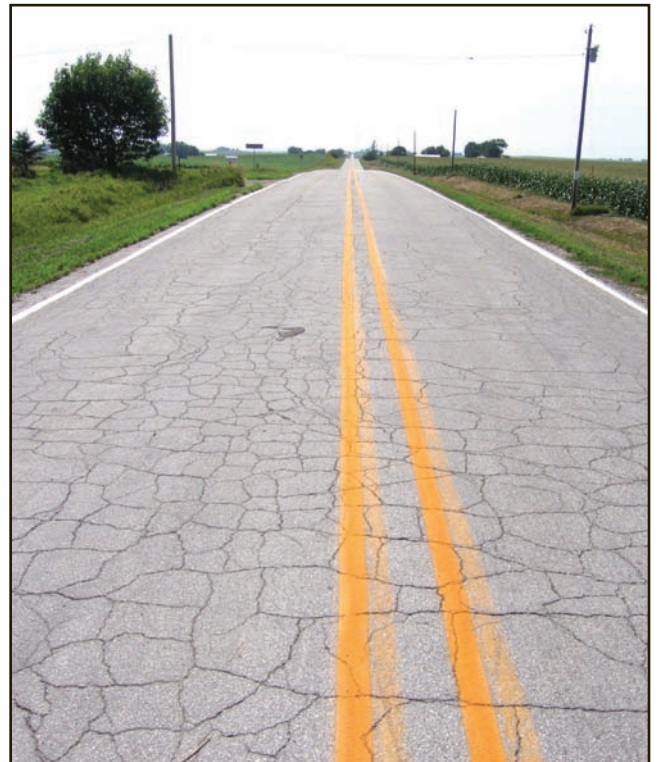
Figure 9. High block cracking ratings are those with cracks wider than 3/4 inch that are spalling. They occur over in large rectangles over the entire pavement.

Cracks form large rectangles in the pavement. The blocks range from 1–10 square feet. Block cracking usually occurs over the entire pavement, not just in wheel paths. Block cracking is not an indication of structural failure.

Block cracking is caused by the shrinkage of the pavement due to daily temperature cycling. It most commonly appears in desert climates where there are wide differences between daytime and nighttime temperatures.

High—Cracks are wider than 3/4 inch and are spalling (figure 9).

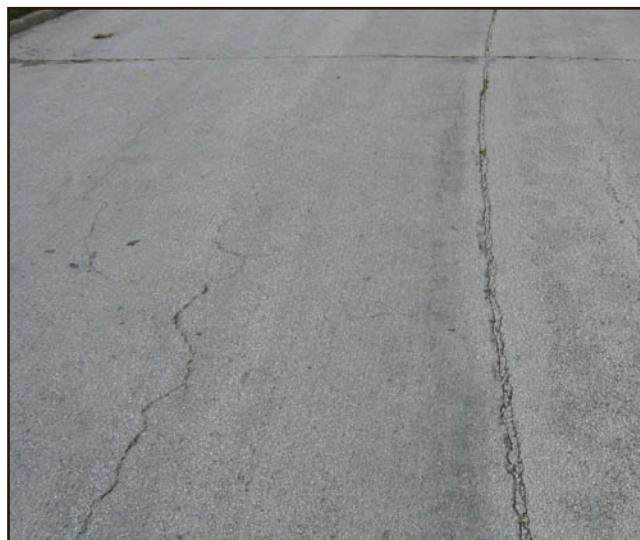
Figure 10. Medium ratings of joint reflection cracking, cracks that mirror joints, are those with cracks $\frac{1}{4}$ to $\frac{3}{4}$ inch wide.

Cracks mirror joints in an underlying overlay or PCC pavement. Cracks are usually very straight and intersect at right angles.

When the joints in the underlying layers move, the surface layer moves and reflects the joint cracks. Movement of the underlying pavement may be vertical, caused by traffic, or horizontal, caused by shrinkage.

Medium—Cracks are $\frac{1}{4}$ to $\frac{3}{4}$ inch wide (figure 10).

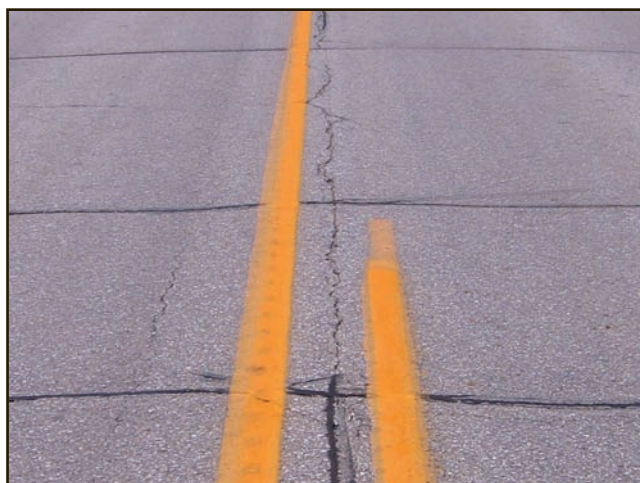
Figure 11. Longitudinal cracking can occur down the centerline where construction joints intersect, parallel to the direction of traffic.

Cracks parallel to the direction of traffic. The cracks are commonly located in wheel paths and at construction joints (figure 11). These cracks indicate structural failure.

Some cracks form at the bottom of the pavement layer under the wheel path and propagate to the surface. Other cracks are formed at construction joints and are caused by a lack of fine aggregate at the surface or poor compaction resulting in a weak bond between the two pavements. Still other longitudinal cracks are caused by paving machine–induced segregation. Sometimes paving machines place excess coarse aggregate in the middle of the screed where the augers are attached to the auger drive shaft. Longitudinal cracks sometimes appear above this coarse aggregate.

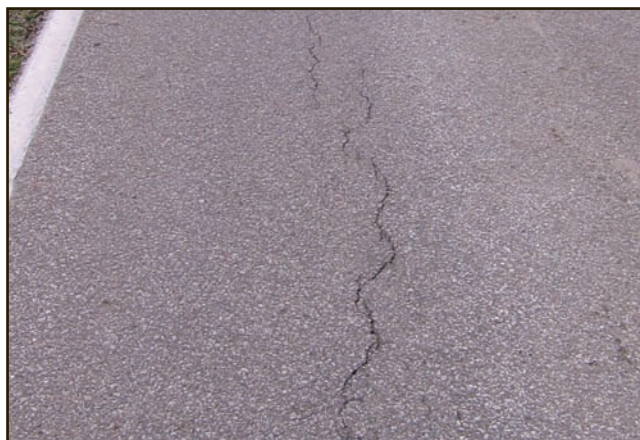
Figure 12. Medium ratings of longitudinal cracking, cracks that parallel the direction of traffic, are those with cracks $\frac{1}{4}$ to $\frac{3}{4}$ inch wide.

Medium—Cracks are $\frac{1}{4}$ to $\frac{3}{4}$ inch wide (figure 12).

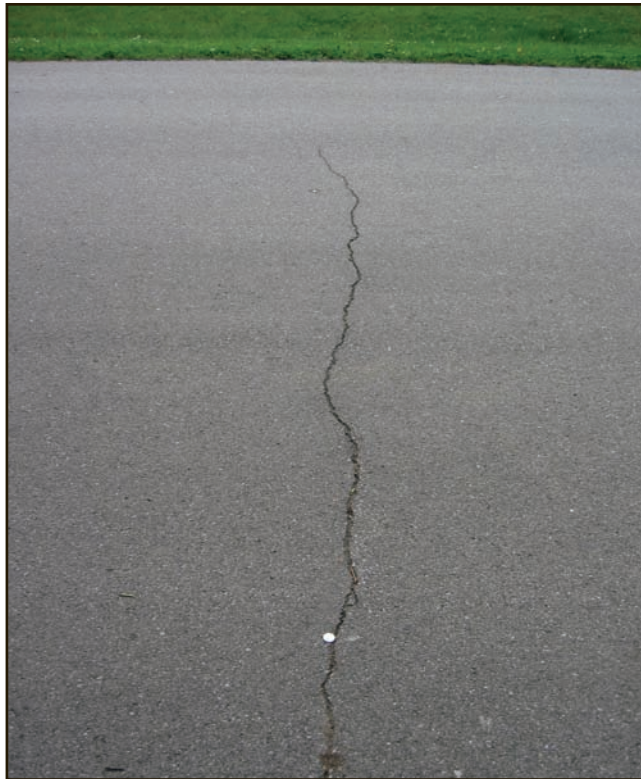
Figure 13. Medium ratings of transverse cracking, cracks that run perpendicular to the direction of the road, are those with cracks $\frac{1}{4}$ to $\frac{3}{4}$ inch wide.

Transverse cracks run perpendicular to the direction of the road. These cracks typically start at the top and move towards the bottom.

Transverse cracks are typically caused by the thermal shrinkage of the pavement.

Medium—Cracks are of medium severity. Cracks are between $\frac{1}{4}$ inch and $\frac{3}{4}$ inch (figure 13).

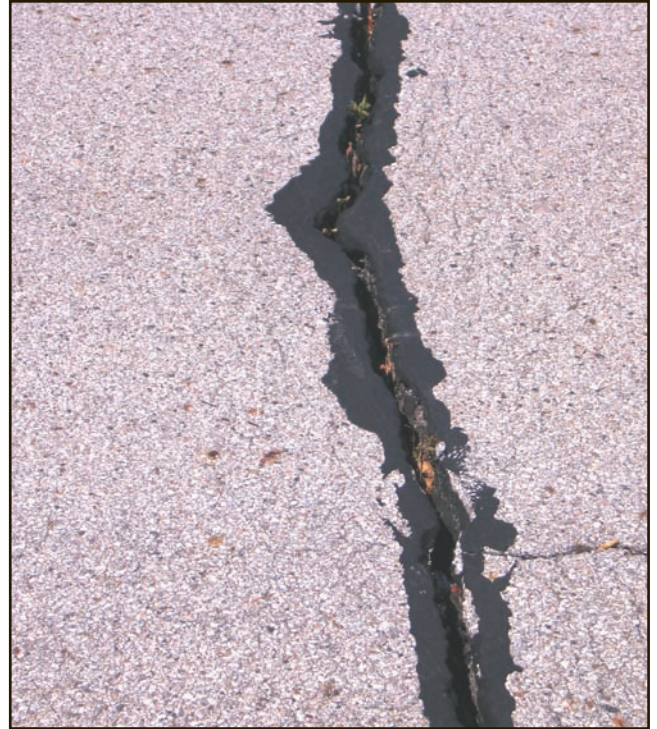
Figure 14. High severity ratings of transverse cracking are wider than $\frac{3}{4}$ inch wide and are spalling.

High—Cracks are of high severity. Cracks are wider than $\frac{3}{4}$ inch and are spalling (figure 14).

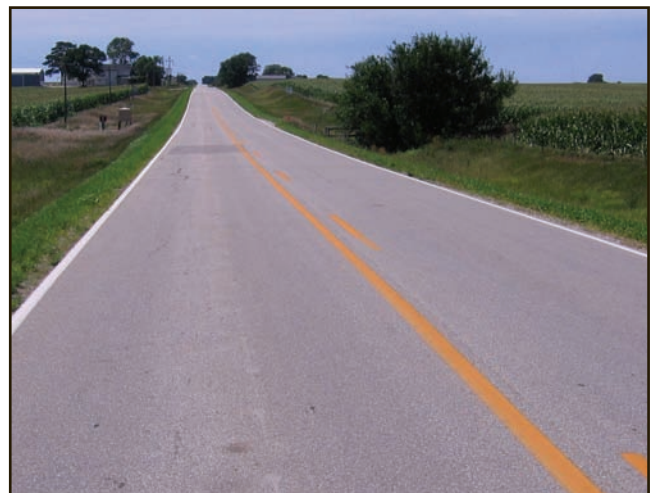
Figure 15. Oxidation of pavement is caused by exposure to the sun and to water, causing binder to become brittle.

Surface of the pavement is a light gray. Surface binder is brittle. Aggregate can be easily removed from the surface (figure 15).

Ultraviolet rays from the sun. Exposure to water.

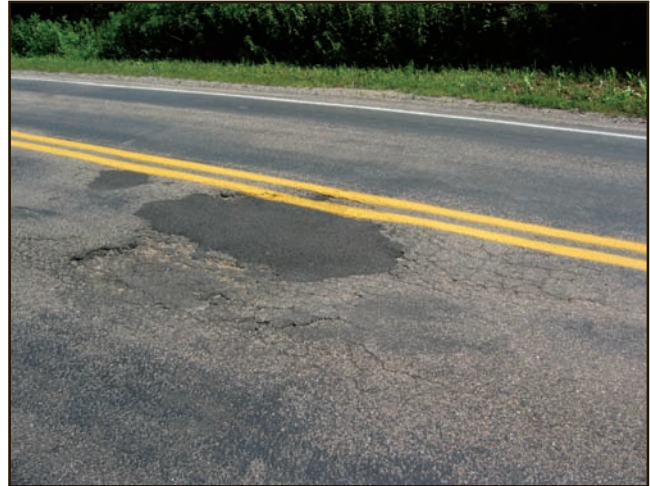
Figure 16. Medium ratings of patching are areas moderately deteriorated that had been replaced with new material.

An area of the pavement has been replaced with new material to repair the existing pavement. This includes pothole and utility patches. Patching is considered a distress because the structure of the pavement has been altered.

Medium—Patch has moderately deteriorated. Ride quality is mediocre (figure 16).

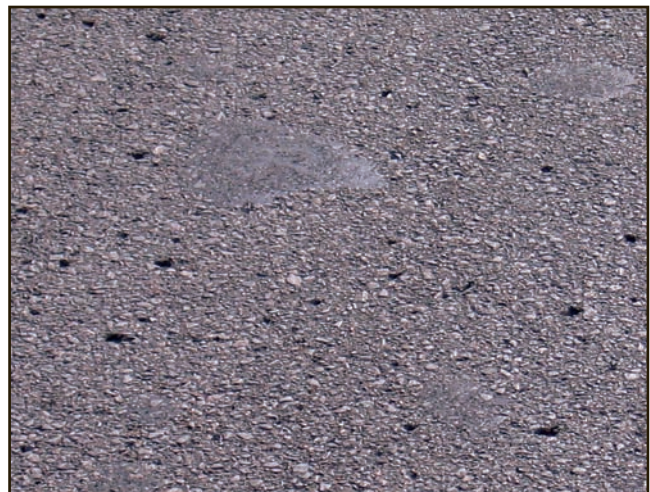
Figure 17. Pocking occurs when pieces of aggregate become dislodge or deteriorate prematurely.

Individual pieces of aggregate have dislodged from the pavement surface and left small voids (figure 17).

In some cases, asphalt binder becomes hard and brittle from oxidation, allowing the stone to break away. In other cases, some pieces of aggregate may expand or prematurely deteriorate and work out of the pavement under traffic or snowplowing.

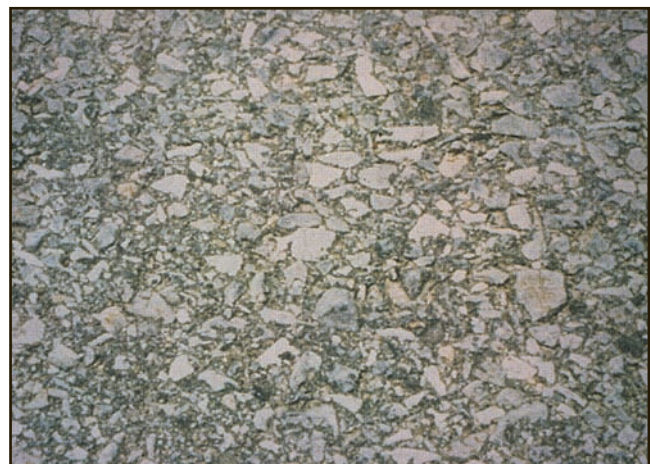
Figure 18. Polished aggregate is smooth pavement with little or no friction. (FHWA)

Smooth appearance of the pavement. When touched, there is little to no friction on the surface of the pavement (figure 18).

Repeated traffic applications. Aggregate with poor abrasion resistance.

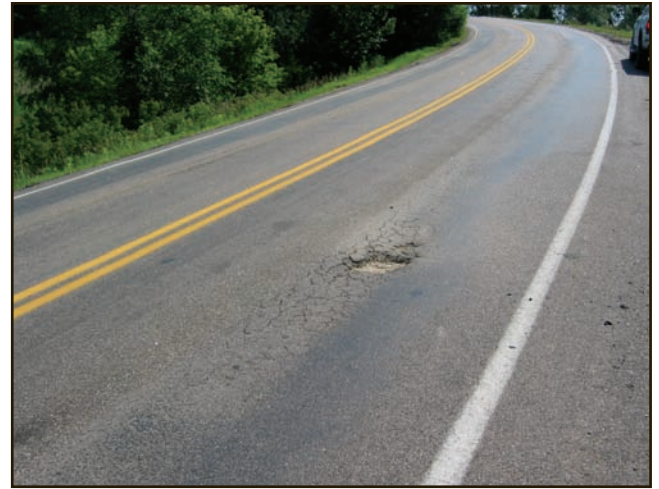
Figure 19. Potholes are a bowl-shaped hole in the pavement surface generally surrounded by alligator cracking.

Bowl-shaped holes in the pavement surface. Generally, the area surrounding the pothole is alligator cracked. Growth is accelerated by water pooling inside of the hole (figure 19 and 20).

Poor surface mixtures or structural failure of the pavement.

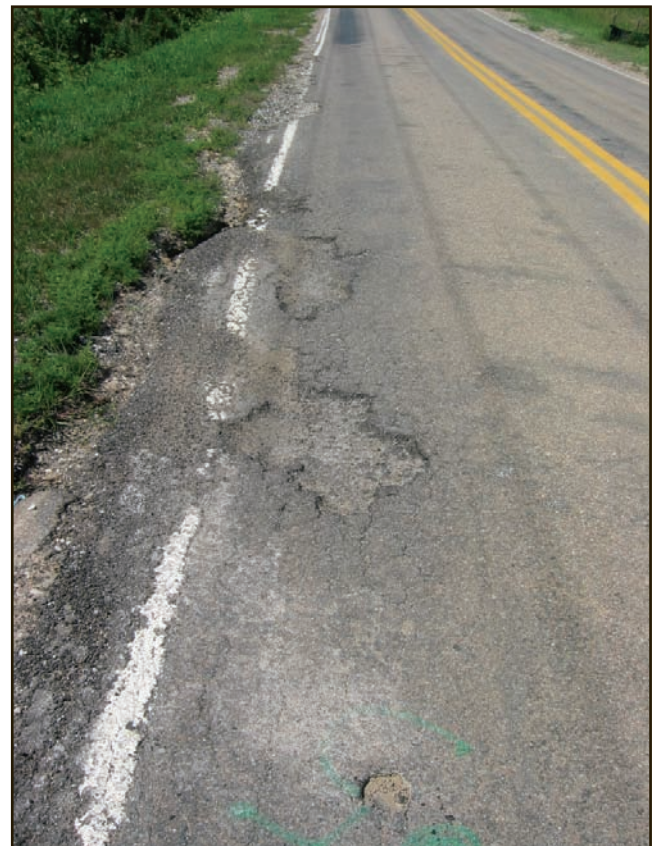
Figure 20. High severity rated potholes are 1–2+ inches deep and range from 18–30 inches in diameter.

Average Diameter of Pothole	Maximum Depth of Pothole		
	½ to 1 in.	1 to 2 in.	> 2 in.
4 to 8 in.	Low	Low	Medium
8 to 18 in.	Low	Medium	Medium
18 to 30 in.	Medium	High	High

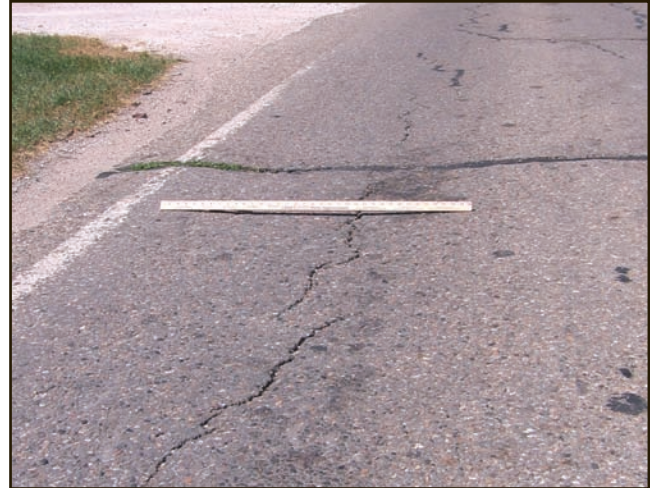
Figure 21. Longitudinal cracks at the bottom of rutting are often caused by structural failure of the subbase.

There are three possible causes. (1) If the pavement has risen around the edges of the rut, the rut is most likely caused by an unstable mix that flows out from under the wheel and moves to the edges. (2) If there are longitudinal cracks at the bottom of the rut, it is most likely caused by structural failure

of the sub-base (figure 21). (3) If the rut has neither of these characteristics, the rut is likely the result of insufficient compaction during construction and subsequent traffic compaction of the asphalt. After a rut is fully compacted, filling it with slurry seal or micro-surfacing can provide a relatively permanent repair. Progressive rutting (rutting that continues to grow deeper and wider) is a result of a poor sub-base or an unstable mix. If rutting is progressive, filling with slurry seal or micro-surfacing will only provide a temporary solution.

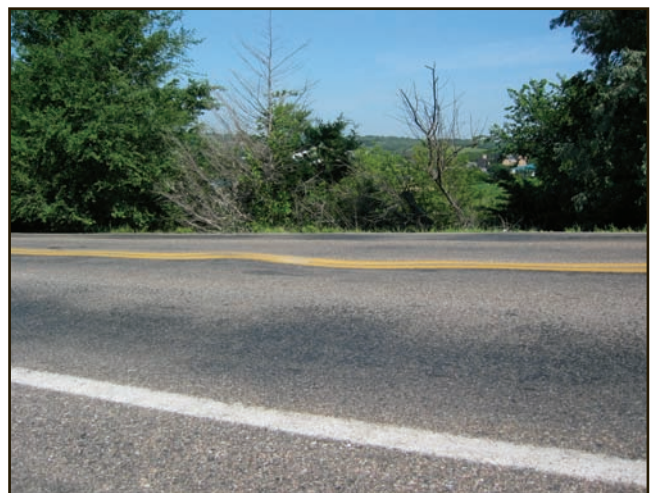
Figure 23. Shoving or corrugation of pavement surface is a longitudinal wave or bump in the asphalt, usually on hills, curves, or intersections.

A permanent longitudinal displacement of a localized area of a pavement surface. Shoving produces a wave or bump in the asphalt. Shoving failures usually occur on hills, curves, and intersections. Shoving can also occur where an asphalt pavement abuts a concrete pavement. Corrugation is the repetition of shoving and is perpendicular to the direction of traffic (figure 23).

Shoving is caused by braking or accelerating vehicles that displace the asphalt mix. When shoving is located at the transition from a PCC to an ACC pavement, it is caused by the thermal expansion of the PCC. The expanding PCC pushes the asphalt pavement, causing the distress.

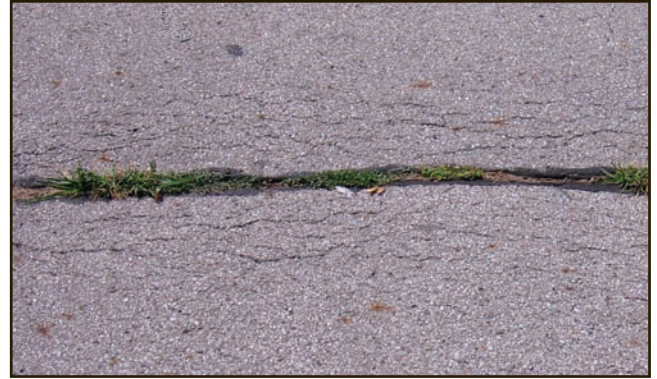
Figure 24. Low level spalling where parallel satellite cracks are beginning to form.

An existing crack of any type begins to form parallel satellite cracks.

Stresses from traffic cause cracks to roll down near the edges. When these stresses are too great on the pavement, new cracks begin to form parallel to the old crack.

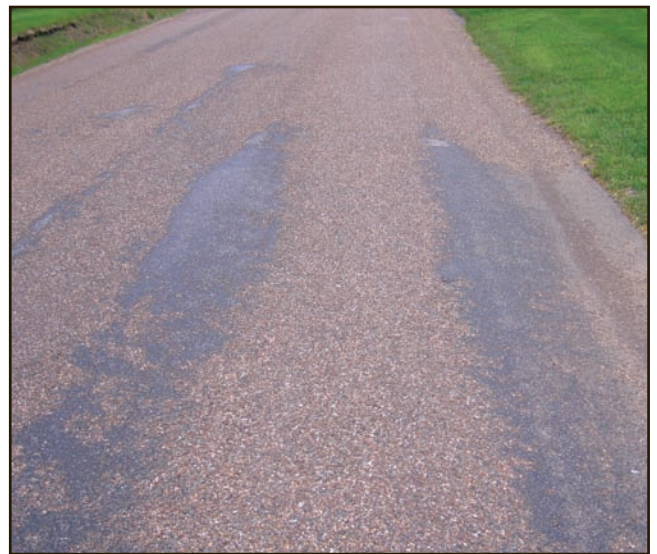
Figure 25. High severity raveling of a seal coat.

The pavement surface is pitted and rough due to loss of aggregate.

Oxidation makes the binder brittle so that pieces of aggregate can break out of the mix. Tracked vehicles or studded tires can also contribute. On thin maintenance surfaces, causes of raveling usually include snow plow damage, traffic, or a poor design. Loss of aggregate may also be caused by an insufficient amount of binder or poor compatibility between the aggregate and binder.

High—Aggregate or binder has worn away considerably. Surface is very rough and severely pitted.

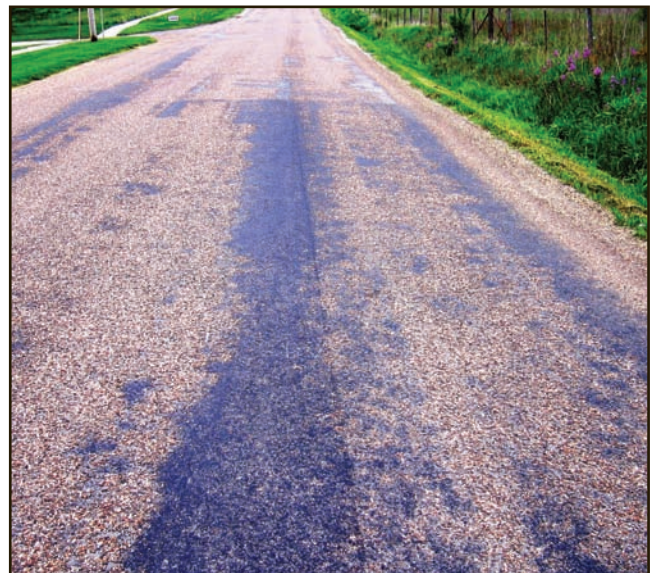
Figure 26. New raveling of a pavement surface.
