**DRAFT
MEMORANDUM**

Subject: 3066 Flying C Road Culvert Structural Evaluation

Date: July 24, 2023

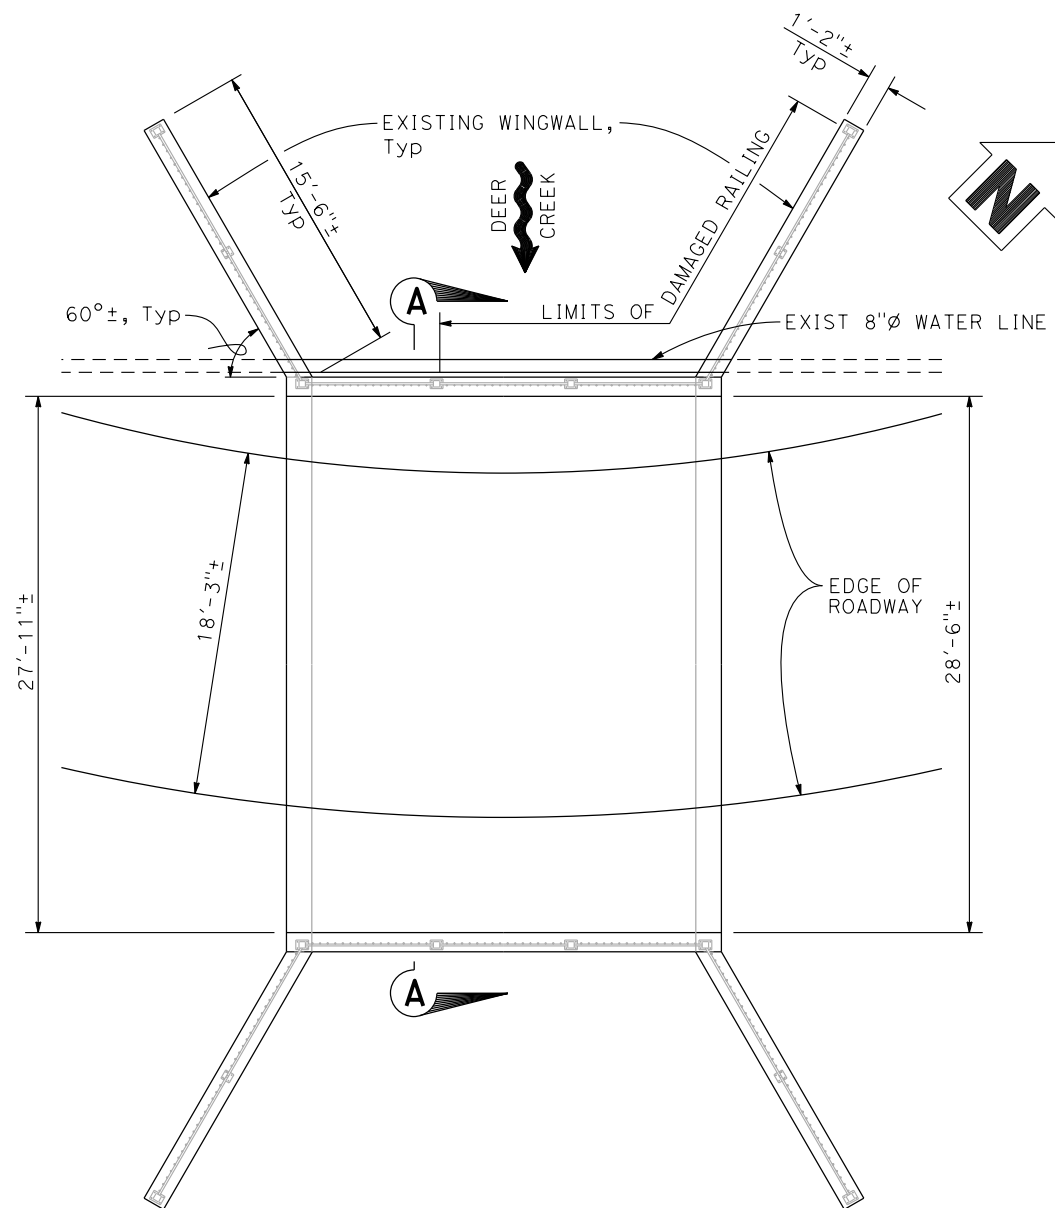
PLAN

- There is spalled concrete at several of the railing post locations where the posts were broken out of the culvert by flood debris.
- There is spalled concrete along the bottom corner of soffit at several location on both the north and south sides of the culvert. These appear to be corrosion-related and are surrounded by areas of unsound concrete.

- There are several longitudinal soffit cracks concentrated near each edge of the culvert slab, but also a number closer to the center. Several of these also exhibit substantial areas of unsound concrete along their lengths and extending up to 5 feet from the edge of soffit.

- There is an area approximately 4 feet square centered about 7 feet from the west abutment wall and 12 feet from the south edge of culvert that exhibited an unusually deep noise indicating some level of delamination, but not typical of surface spalling. Dokken was unable to identify the

source of this phenomenon. It may be related to a horizontal plane of delamination closer to mid-depth of the 1'-10" deep slab. Taking cores through the deck would be the most effective way to determine the cause.

- Within the next year, take 2 to 3 concrete cores through the deck and have visual and strength analysis performed to determine extent of soffit cracking and delamination.

- Remove unsound concrete along the corners of the deck slab to approximately $\frac{3}{4}$ " beyond the nearest longitudinal bar. Clean reinforcement and treat with corrosion inhibitor. Install drill and bond dowels if spalled areas are greater than 4 inches deep. Patch with material suitable for overhead construction per the Caltrans Authorized Materials List.

- Epoxy-inject soffit cracks.
- If analysis of cores indicates a layer of unsound concrete on the soffit, remove and patch as described above for the deck slab corners.
